Effect of UVC Exposure on Non-Metallic Materials in HVAC Systems

I. Executive Summary

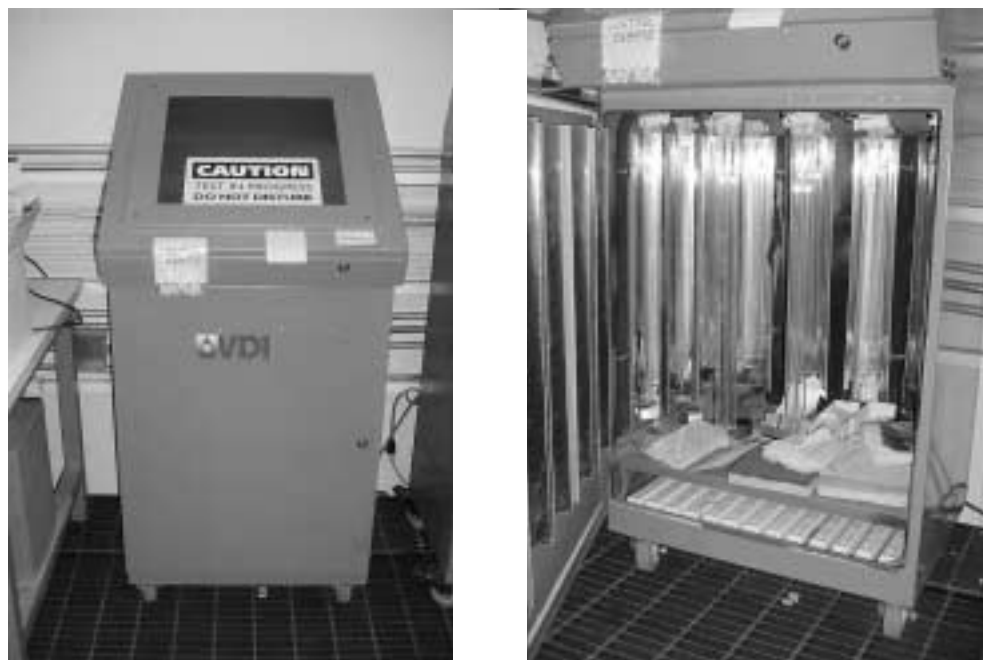
Figure 1 – Ultraviolet Exposure Test Chamber

Testing was conducted in a chamber designed specifically for evaluating the effect of UVC exposure on various materials. Twelve 55-watt UVC lamps power the interior of the test chamber, shown below in Figure 1. The high UVC output of the lamps, the reflectivity

of the interior of the chamber, and the geometry of the chamber result in a measured UVC intensity at the floor of the chamber that is *27 times* the intensity from a single coil irradiation lamp at an 18 inch distance. This is the assumed acceleration factor in the test.

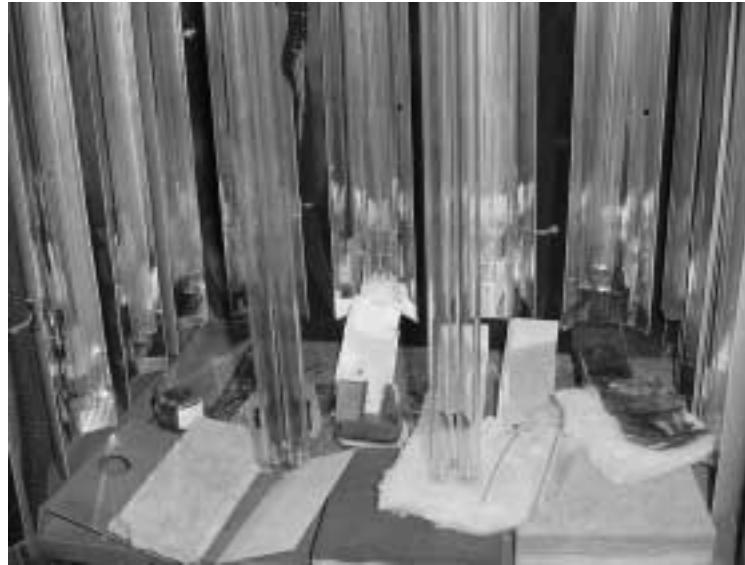
Figure 2 – Materials Under Test in Chamber

The test consists of placing material samples on the floor of the chamber and allowing long term exposure to take place, periodically evaluating the materials for changes from the control, unexposed samples. While the primary focus of the test was to evaluate drain pans from various manufacturers, at the request of customers we also included samples of lined flex duct, duct

board, wood studs, and wire insulation. Figure 2 shows a sampling of the materials under test. Detailed test results are shown in Appendix D.

Results of the test thus far are summarized in Table A-1. The length of time in the chamber (as of 10/6/00) for the drain pan samples varies from 86 to 144 days, for an equivalent exposure of 6.4 to 10.7 years. The effects on the materials have been limited to color changes and slight changes in the surface finish (surface chalkiness or crystallization). No brittleness or structural degradation was noted in any of the samples.
